Manhole Inspection Summary

Manhole # S19I1_028MH

Insp Date: **4/18/08 2:24 PM**

Location Address: **3040 elizabeth av**

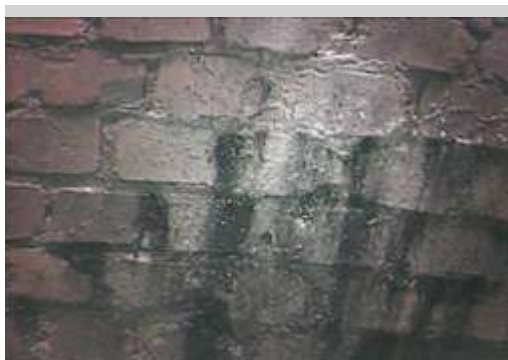
Defect 5

Infiltration: ☐ None ☐ Joint ☐ Cracks ☐ Mortar ☐ Roots ☒ **Wall**

infiltration @ barrel wall

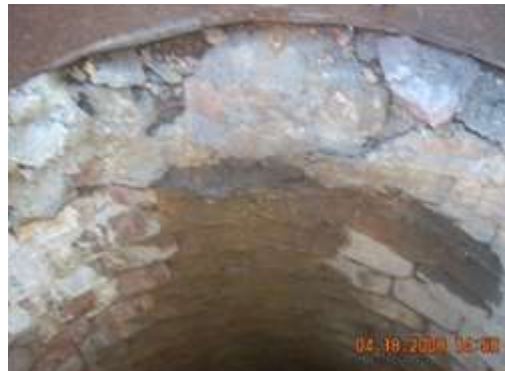
Defect 4

Infiltration: ☐ None ☒ **Joint** ☐ Cracks ☐ Mortar ☐ Roots ☐ Wall

infiltration @ chimney/corbel joint

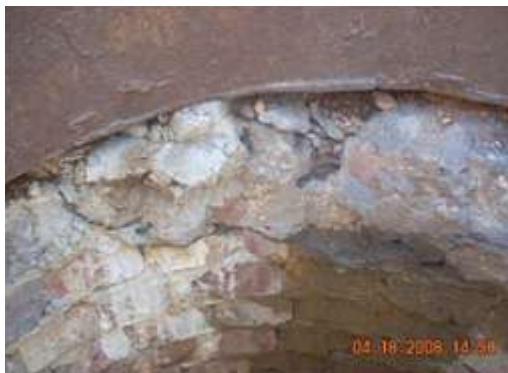
Defect 3

Condition: ☐ Sound ☐ Cracked ☐ Root Intrusion ☐ Loose Brick ☒ **Deteriorated**

deteriorated concrete chimney

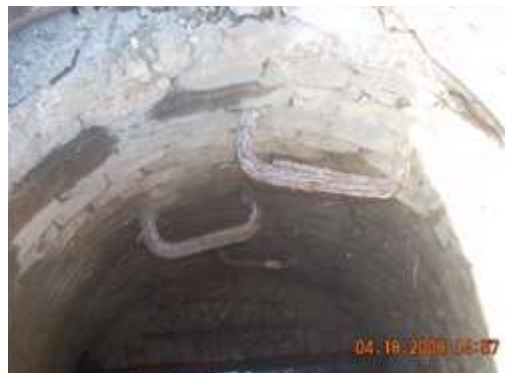
Defect 2

Condition: ☐ Sound ☐ Cracked ☐ Root Intrusion ☐ Deteriorated ☐ Leaks ☒ **Debris**

Steps Count: **4** Missing: **0** ☒ **Corroded**

corroded steps, bench debris

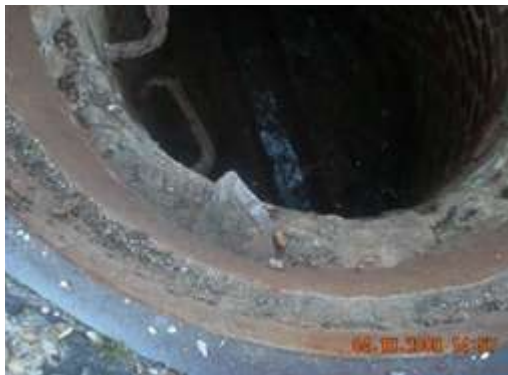
Defect 1

Frame Offset: **3** (in.) Condition: ☒ Sound ☐ Cracked ☐ Leaks

frame offset

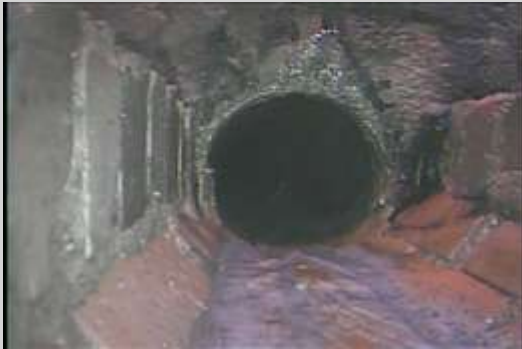
12 O'Clock Outflow

Pipe Height: **8.4** (in.) Rod and Bar (Angled)
Pipe Material: **Clay** ☐ Pipe Lined
Invert Depth: **7.95** (ft.) Flow Characteristics: **Slow**
Deposits: ☒ None ☐ Mud ☐ Sludge ☐ Debris ☐ Grease
Silt Depth: **0** (in.) Deposits Extent:
Infiltration: **Evidence** Pipe Seal Cond: **Roots**

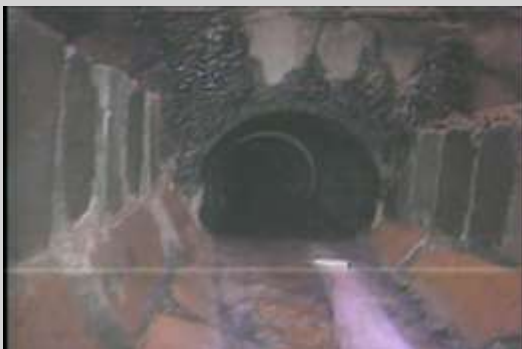
6 O'Clock Inflow

Pipe Height: **8.4** (in.) Rod and Bar (Angled)
Pipe Material: **Clay** ☐ Pipe Lined
Invert Depth: **7.91** (ft.) Flow Characteristics: **Slow**
Deposits: ☒ None ☐ Mud ☐ Sludge ☐ Debris ☐ Grease
Silt Depth: **0** (in.) Deposits Extent:
Infiltration: **Weeper** Pipe Seal Cond: **Unknown**
